EXHIBIT 22

From: Non-responsive content removed
To: [REDACTED]
CC: [REDACTED]
Date: 10.06.2011 08:15:44
Thema: WG: 112869 - 2.0l TDI Fuel Pump

Topic: FW: Radio RE: [REDACTED] RE: Radio: Drivetrain damage failure US07 (Jetta) v_27_03_08 v_28_03_08

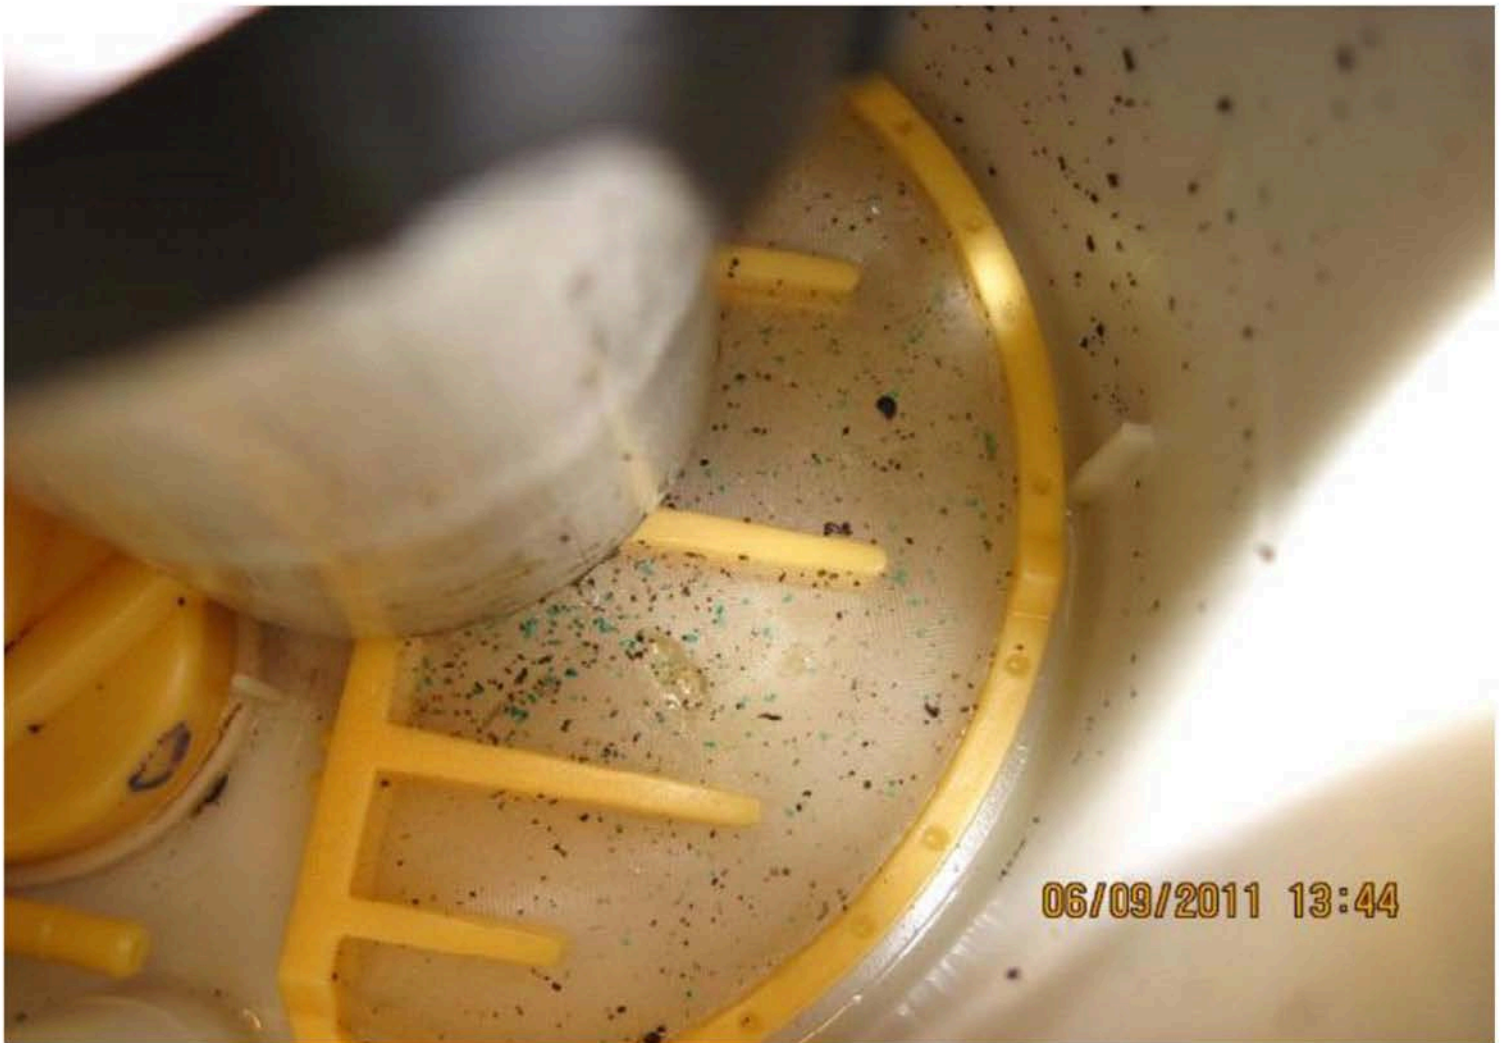
I have here a pump from the a 2.0l TDI. I have been testing a lot of these this week and many have an amount of "metal Debris" or other metallic particles in them. I believe we are also having an issue with water in the fuel. For this issue there will be a report very shortly. However, this pump contains something else. The green particles are gel like but still fluid. Can you please get this material analysed in Zentral Labor and then I can add the findings to the report or create a single report for it.
